Review of Vegetation Monitoring
Surrounding Fimiston I and Fimiston II
Tailings Storage Facilities
For
Kalgoorlie Consolidated Gold Mines

Final

December 2005

Prepared by:
Jim's Seeds, Weeds & Trees Pty Ltd
PO Box 2027
Boulder WA 6432

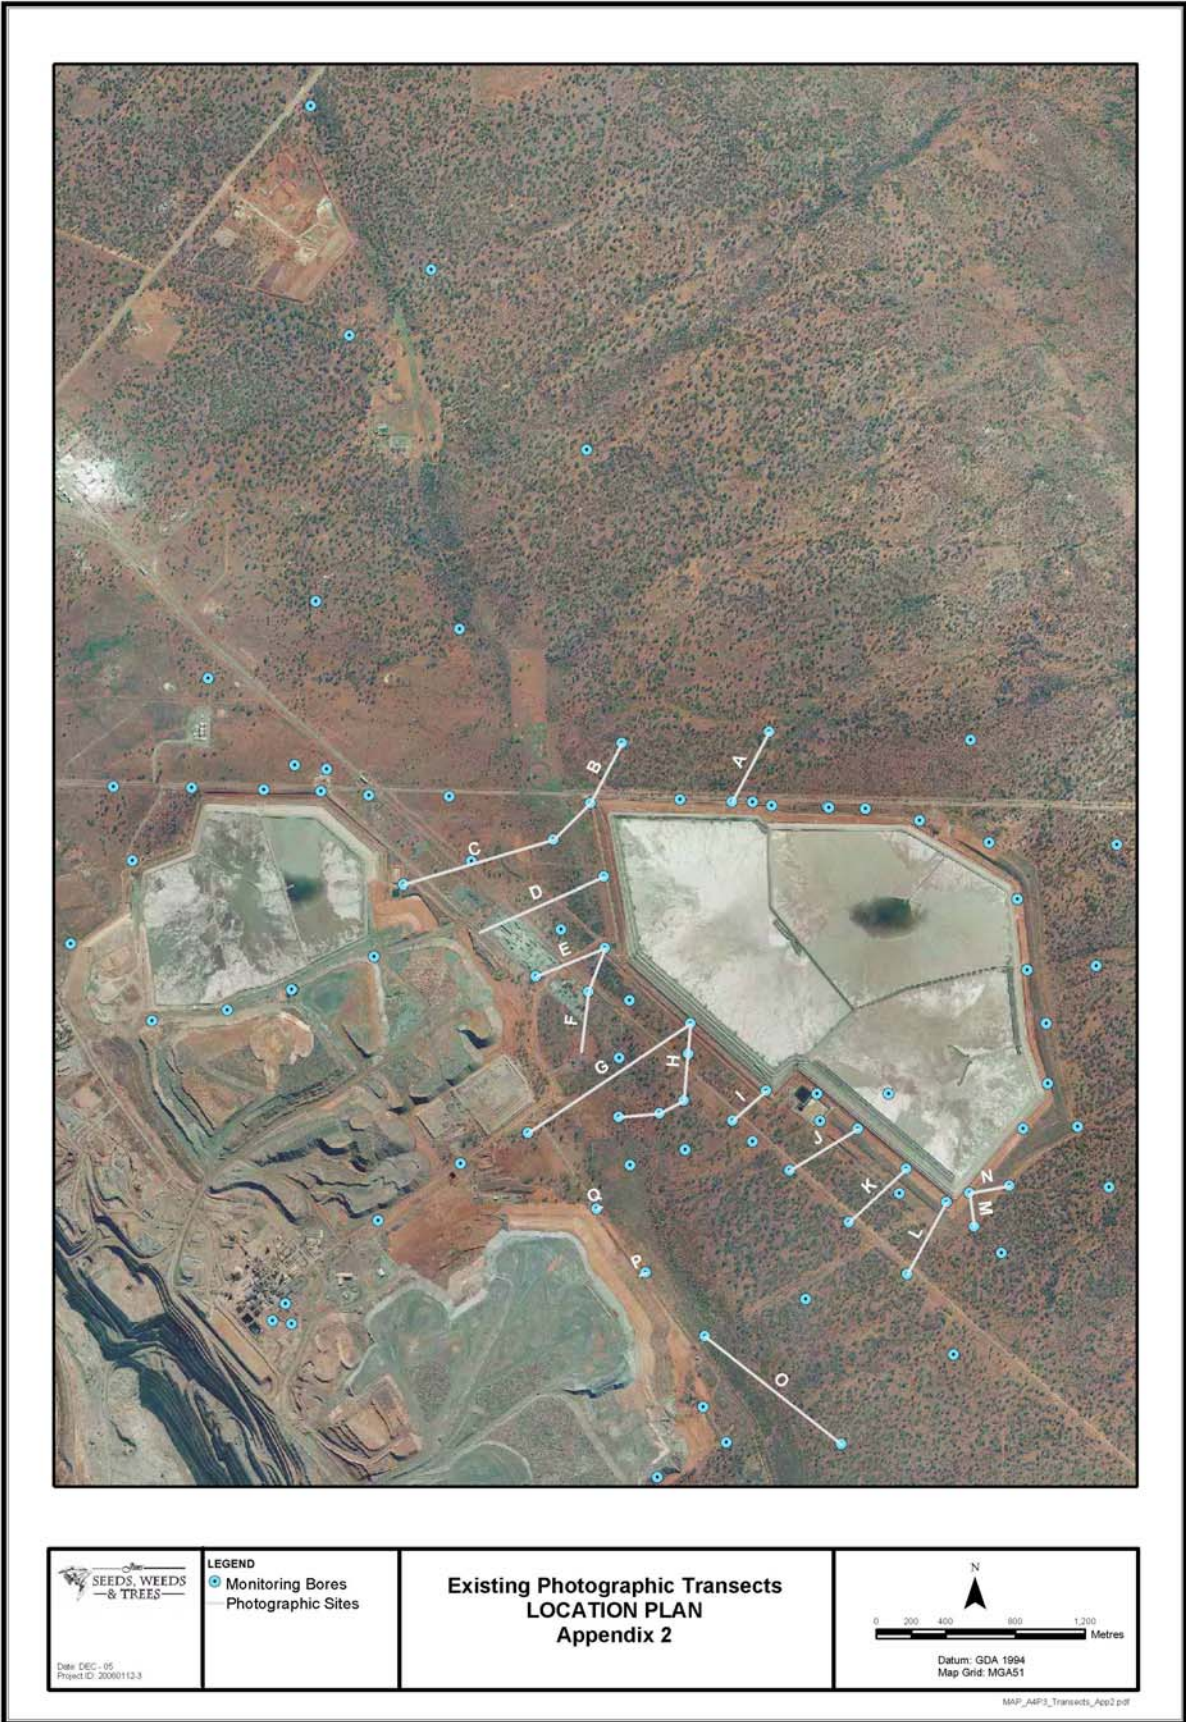
Appendix 2: Existing Vegetation Monitoring Program

Transect	Origin (Bore)	Sequence of Bores	Photographic Monitoring
A	NTD 1 (n)	MB F1 (n;s)	√
B	NTD 2 (w)	MB F4 (n;s)	√
C	NTD 2 (nw)	MB F6 (e;w) MB F5 (se)	√
D	NTD 3 (w)	AMG (358537:6597384) (e)	√
E	NTD 4 (nw)	AMG (358884:6597023) (e)	√
F	NTD 4 (sw)	MB F32 (e;w), NEVES DAM (e;w)	√
G	NTD 5 (sw)	MB F24 (e)	√
H	NTD 5 (sw)	MB F19 (sw;ne), MB F33 (w;e), MB F31 (w;e)	√
I	NTD 6 (sw)	MB F54 (w;e)	√
J	MB F51 (sw)	MB F55 (sw;ne)	√
K	MB F50 (sw)	MB F56 (sw;ne)	√
L	MB F48 (sw)	MB F57 (sw;ne)	√
M	MB F46 (sw)	MB F47 (n;s;e;w)	√
N	MB F46 (e)	MB F45 (n;s;e;w)	√
O	MB F30 (n;s;e;w)		√
P	MB F26 (e)		√
Q	MB F25 (e)		√

Note: The direction of the photographs is bracketed, and in italics, next to the groundwater bore number. A semicolon separates multiple photographs at one photopoint. Where a monitoring bore is not present the AMG coordinates are given. The numbering system used for photographs below is, for example, A1 where A is the transect and 1 is the origin bore. Successive photograph points, along a transect, are numbered left to right from Table 1.

Photographic monitoring is currently undertaken at KCGM between the eastern side of Fimiston I TSF and western side of Fimiston II TSF. KCGM established 32 points in 1999, with wooden pegs set up to mark the position of each photograph. The photographic positions were chosen to depict the vegetation associated with the natural floodway oriented north-south, situated immediately west of Fimiston II TSF (Appendix 2).

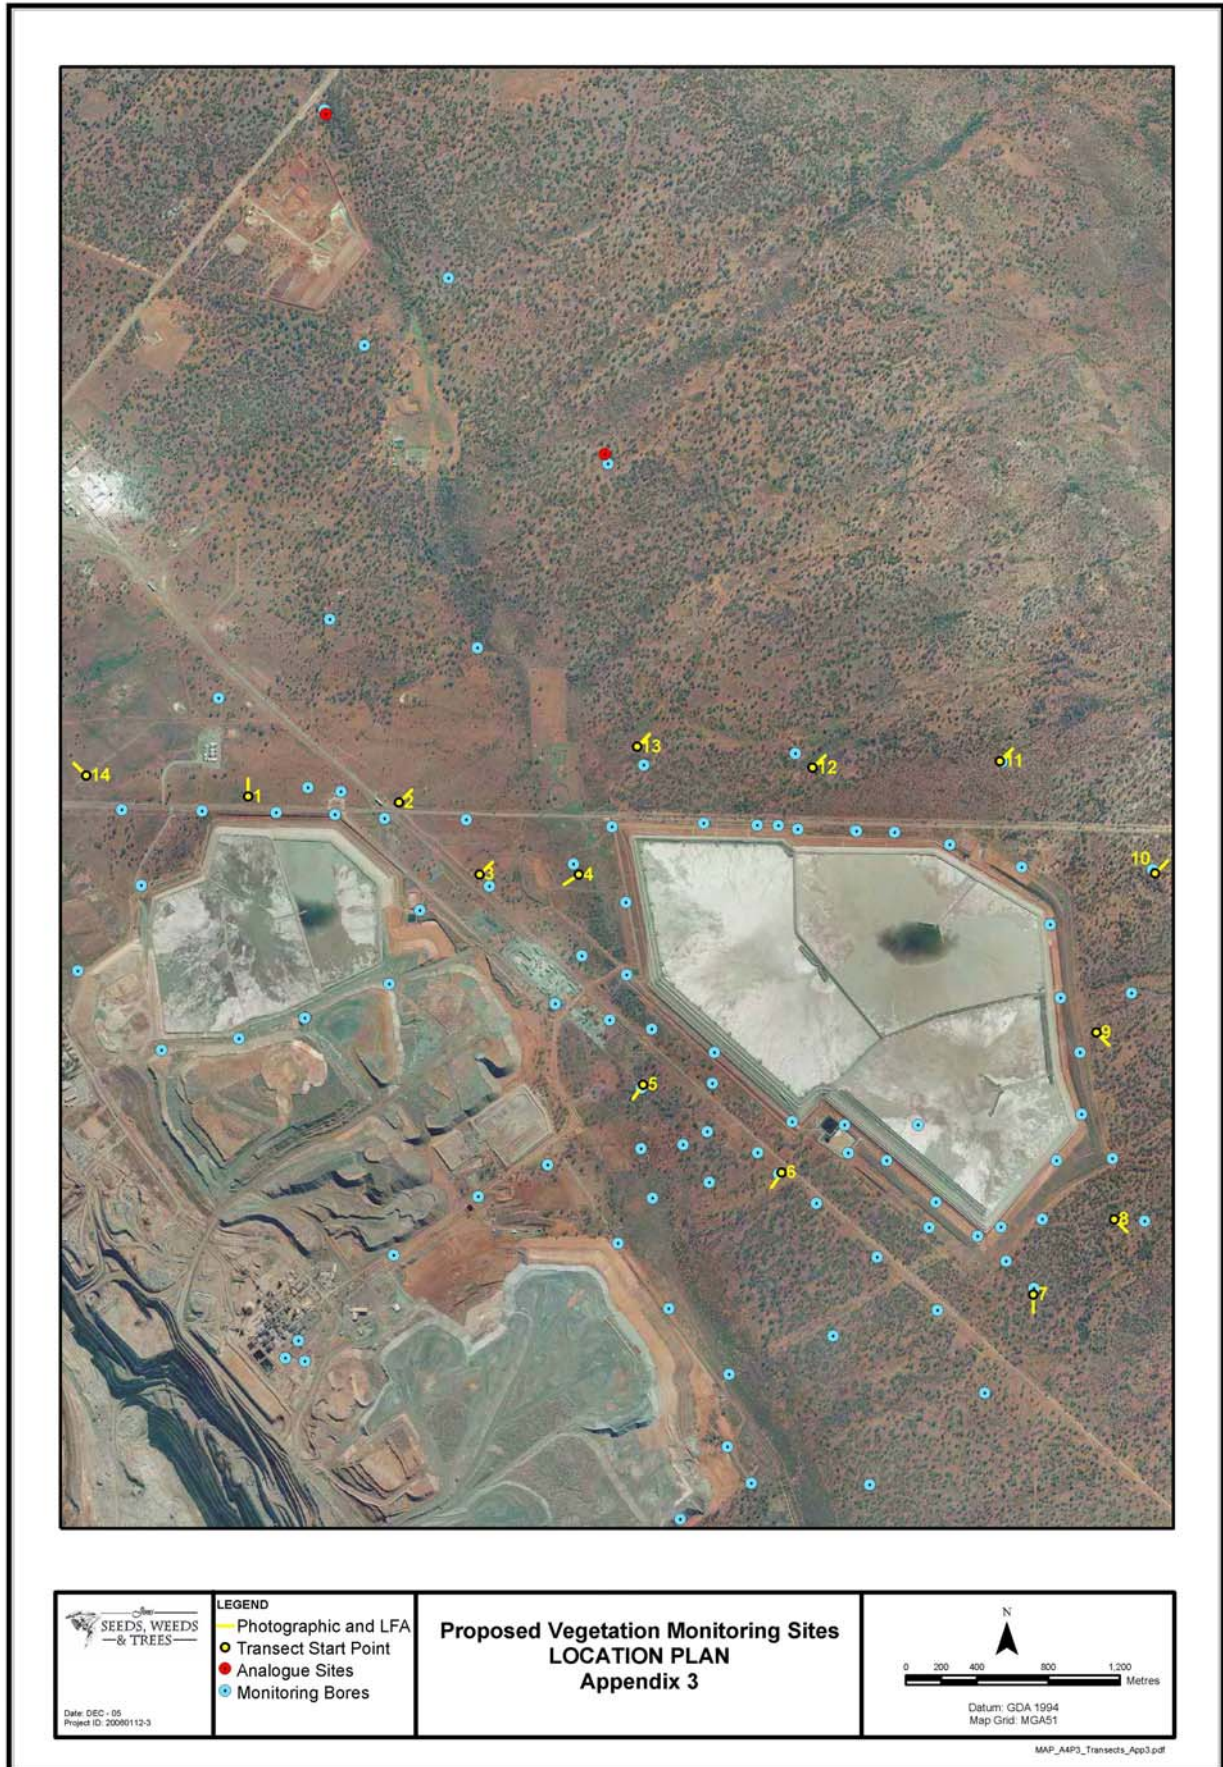
Appendix 3: Proposed Additional Vegetation Monitoring Sites

Transect	Coordinates (GDA94 51J)		Photographic Transect Direction	Proposed Photographic Monitoring	Proposed LFA Monitoring
	mE	mN			
1	357230	6598237	N	√	√
2	358075	6598205	NE	√	√
3	358526	6597800	NE	√	√
4	359082	6597799	W-SW	√	√
5	359443	6596620	SW	√	√
6	360218	6596126	SW	√	√
7	361629	6595441	S	√	√
8	362081	6595864	SE	√	√
9	361982	6596912	SE	√	√
10	362310	6597806	NE	√	√
11	361441	6598436	NE	√	√
12	360392	6598399	NE	√	√
13	359408	6598518	NE	√	√
14	356322	6598356	NW	√	√
Analogue 1	359228	6600158	-	x	√
Analogue 2	357667	6602068	-	x	√

Using the same methodology, it is recommended that additional photographic monitoring transects should be established, in order to ensure that a uniform representation of vegetation health that surrounds the TSFs is obtained. The proposed additional photographic monitoring transects are depicted in Appendix 3. These suggested locations should have photographic points situated every 100m along the transect directed 300m away from its associated TSF. The direction of each photograph is outlined in Appendix 3.

Proposed locations of the monitoring transects (1-3 & 14) around Fimiston I TSF and monitoring Transects (4 -13) around Fimiston II TSF (Appendix 3) will be placed at or near additional groundwater monitoring bore sites established as part of the SGMP.

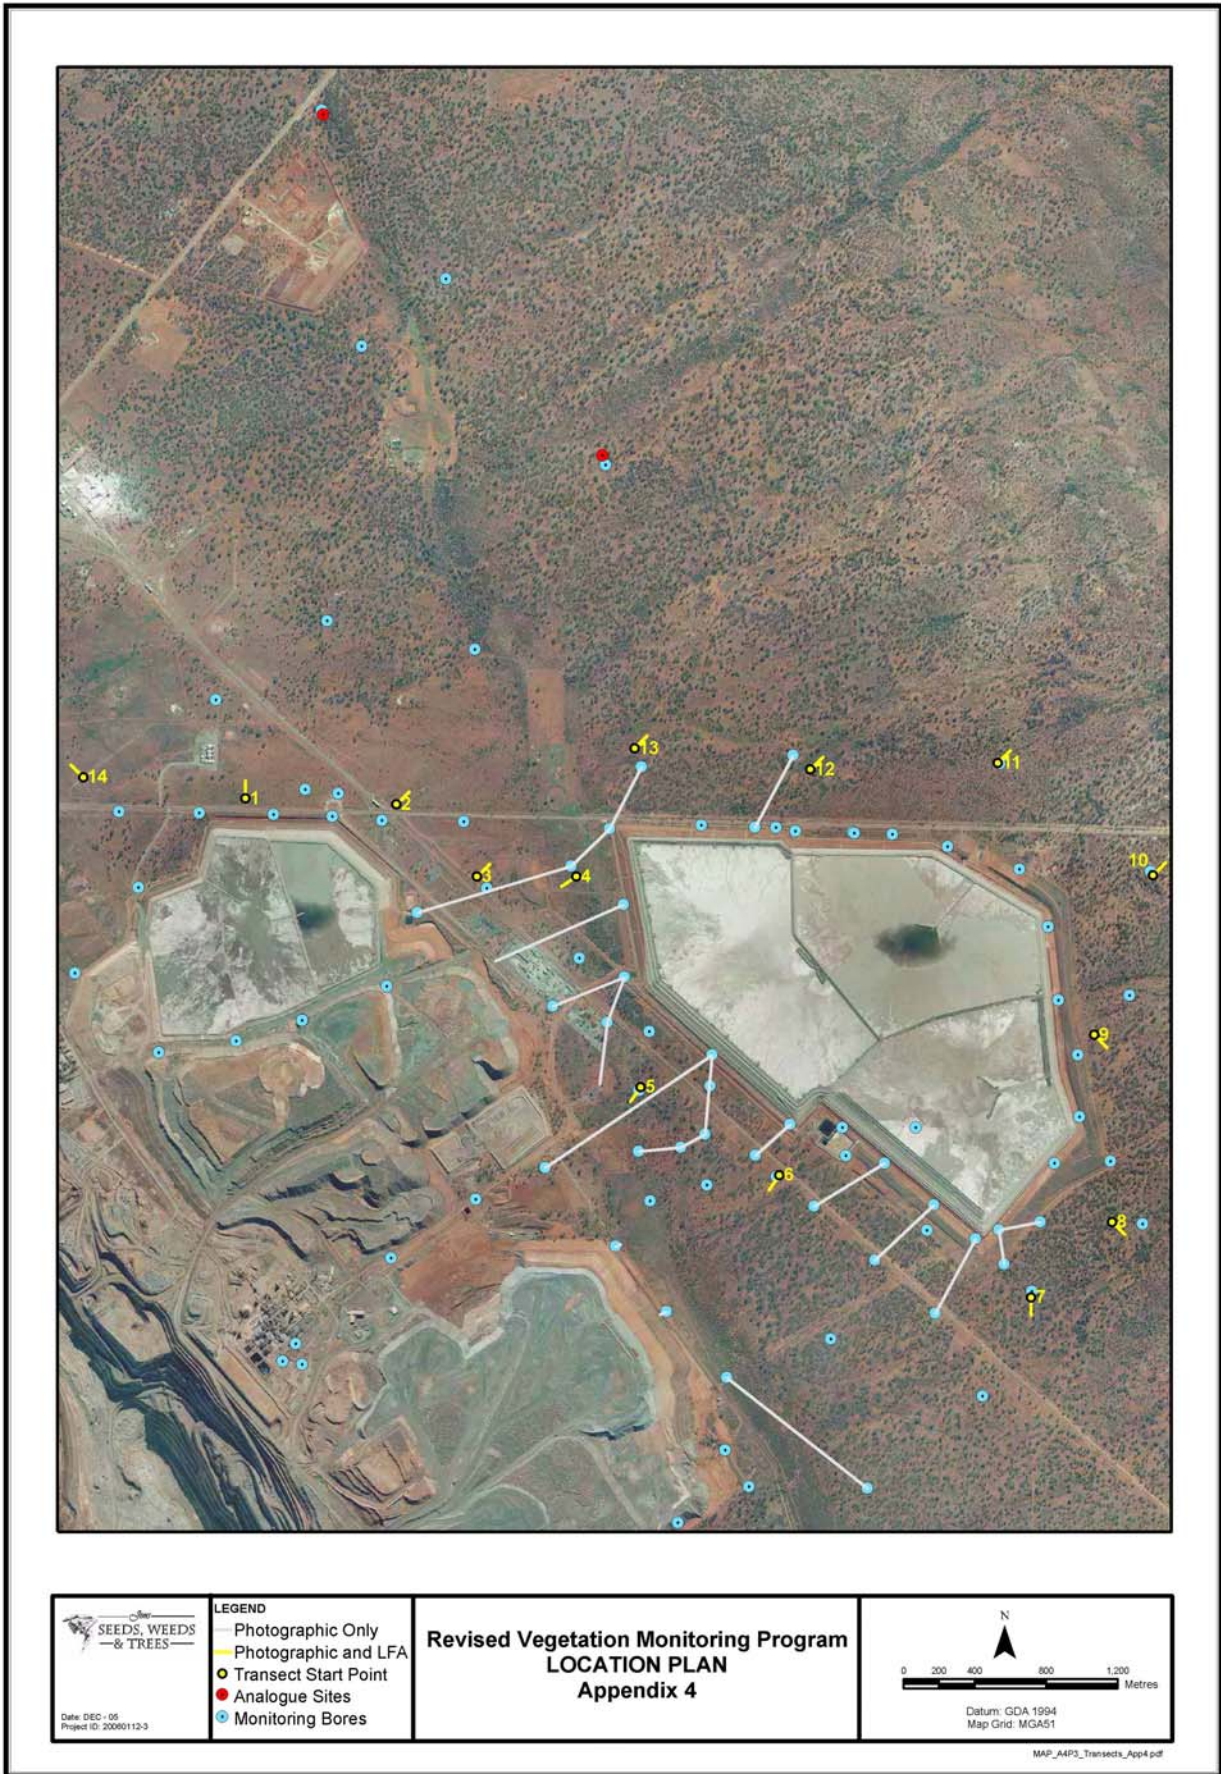
Appendix 4: Revised Vegetation Monitoring Program

Transect	Associated Bore	Photographic Direction	Photographic Monitoring	LFA Monitoring
A	NTD 1	N	√	x
B	NTD 2	W	√	x
C	NTD 2	NW	√	x
D	NTD 3	W	√	x
E	NTD 4	NW	√	x
F	NTD 4	SW	√	x
G	NTD 5	SW	√	x
H	NTD 5	SW	√	x
I	NTD 6	SW	√	x
J	MB F51	SW	√	x
K	MB F50	SW	√	x
L	MB F48	SW	√	x
M	MB F46	SW	√	x
N	MB F46	E	√	x
O	MB F30	N:S:E:W	√	x
P	MB F26 (e)	E	√	x
Q	MB F25 (e)	E	√	x
1	PBF111 (near)	N	√	√
2	MBF81 (near)	NE	√	√
3	MBF 82 (near)	NE	√	√
4	MBF6 (near)	W-SW	√	√
5	MBF83	SW	√	√
6	PBF82	SW	√	√
7	MBF79	S	√	√
8	MBF78 (near)	SE	√	√
9	PBF112	SE	√	√
10	MBF76	NE	√	√
11	MBF75	NE	√	√
12	MBF1	NE	√	√
13	MBF4 (near)	NE	√	√
14	MBF72 (near)	NW	√	√
Analogue 1	MBF74	-	x	√
Analogue 2	MBF80	-	x	√

The combined current and proposed vegetation monitoring program is depicted in Appendix 4.
